Post Installation Troubleshooting Guide

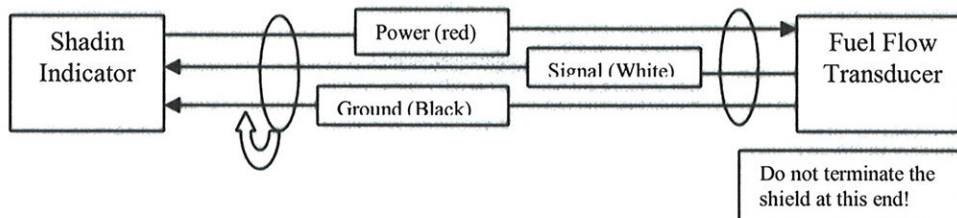
- 1) When installing a “bare” Floscan transducer (Shadin P/N 68050X), make sure the transducer is in a horizontal position with the 3 wires pointing directly up. Failure to follow this tip will result in premature failure of the transducer and erratic readings.

*Remember: Horizontal,
with wires straight up!*

- 2) When tightening the AN fittings on the Floscan transducer (Shadin P/N 68050X), the maximum torque pressure to be used is 15ft/Lbs!
- 3) Do not ground the black wire (Ground) at the engine block. Carry the Ground back the Shadin fuel flow indicator. Failure to follow this suggestion may result in inaccurate fuel readings (because of differences in Ground potential).
- 4) When installing a Shadin Fuel system, it is recommended that the installer use 3 conductor, 22 gauge, shielded wire to run between the transducer(s) and the Shadin fuel indicator. The shield should be terminated at the indicator end, not at the transducer end. Failure to follow this recommendation will result in the possibility of a 10-16% error (on the high side) caused by electronic “noise” on board the aircraft.
